DEPARTMENT OF TRANSPORTATION

Contract #: 04-0120F4Cty: SF/ALA Rte: 80 PM: 13.2/13.9File #: 69.28**WELDING INSPECTION REPORT****Resident Engineer:**Siegenthaler, Peter**Address:** 333 Burma Road**City:** Oakland, CA 94607**Report No:** WIR-021661**Date Inspected:** 10-Mar-2011**Project Name:** SAS Superstructure**OSM Arrival Time:** 700**Prime Contractor:** American Bridge/Fluor Enterprises, a JV**OSM Departure Time:** 1900**Contractor:** Zhenhua Port Machinery Company, Ltd (ZPMC), Changxing Island **Location:** Shanghai, China

WELDING INSPECTION REPORT

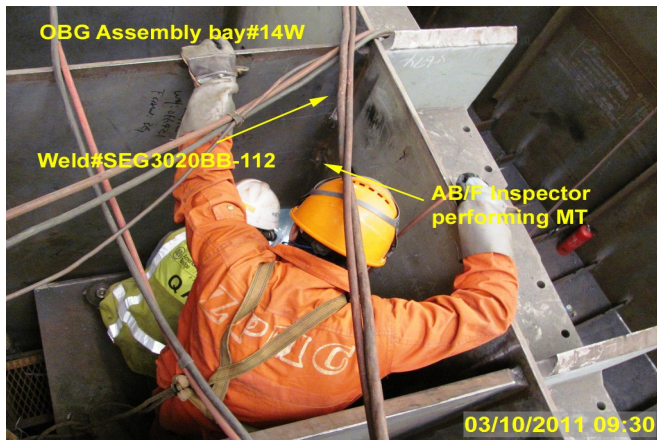
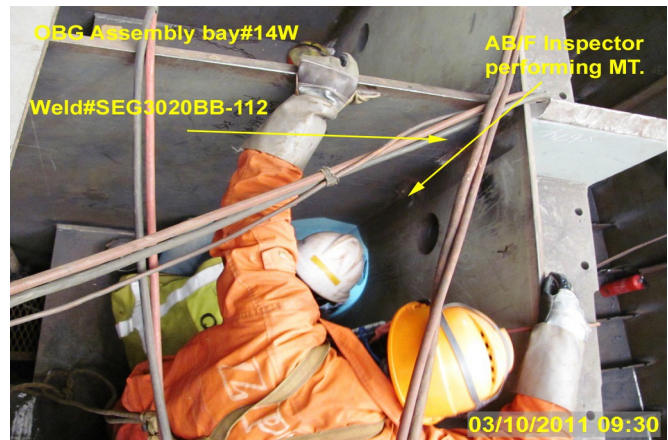
AB/F QA Inspector performing Magnetic Particle Testing for the weld repair excavated area on weld joint identified as SEG3020BB-112. Refer the attached photos for reference.
